# Evaluating earthquake-related ground failure mapping by combined traditional and modern methods

Takayuki NAKANO<sup>a, \*</sup>, Hiroshi UNE<sup>a, +</sup>, Kazuki YOSHIDA<sup>a</sup>, Satoshi FUJIWARA<sup>a</sup>, Tomokazu KOBAYASHI<sup>a</sup>

<sup>a</sup> Geospatial Information Authority of Japan, [nakano-t96fj@mlit.go.jp](mailto:nakano-t96fj@mlit.go.jp), [hiroune@mb.infoweb.ne.jp](mailto:hiroune@mb.infoweb.ne.jp), [yoshida-k96g4@mlit.go.jp](mailto:yoshida-k96g4@mlit.go.jp), [fujiwara-s2vq@mlit.go.jp](mailto:fujiwara-s2vq@mlit.go.jp), [kobayashi-t96dv@mlit.go.jp](mailto:kobayashi-t96dv@mlit.go.jp)

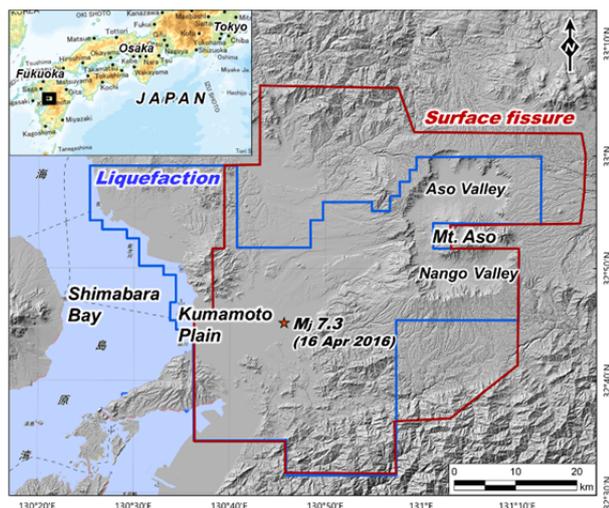
Figure 1. Coverage of ortho-mosaic images. Brown frame: interpretation range of surface fissures, blue frame: interpretation range of liquefaction.

The aerial photos used to interpret each type of ground failure were taken by the Geospatial Information Authority (GSI) of Japan on the 16<sup>th</sup>, 19<sup>th</sup>, 20<sup>th</sup>, and 29<sup>th</sup> April 2016, after the earthquake. The ground sampling distance (GSD) of the aerial photo was approximately 20 cm. Although ortho-mosaic images were created from the aerial photos, it has been resampled and the GSD is greater than 20 cm. The spatial coverage of ortho-mosaic images is shown in Figure 1. Type 1 and 2 ground failure were interpreted and mapped within these areas respectively.

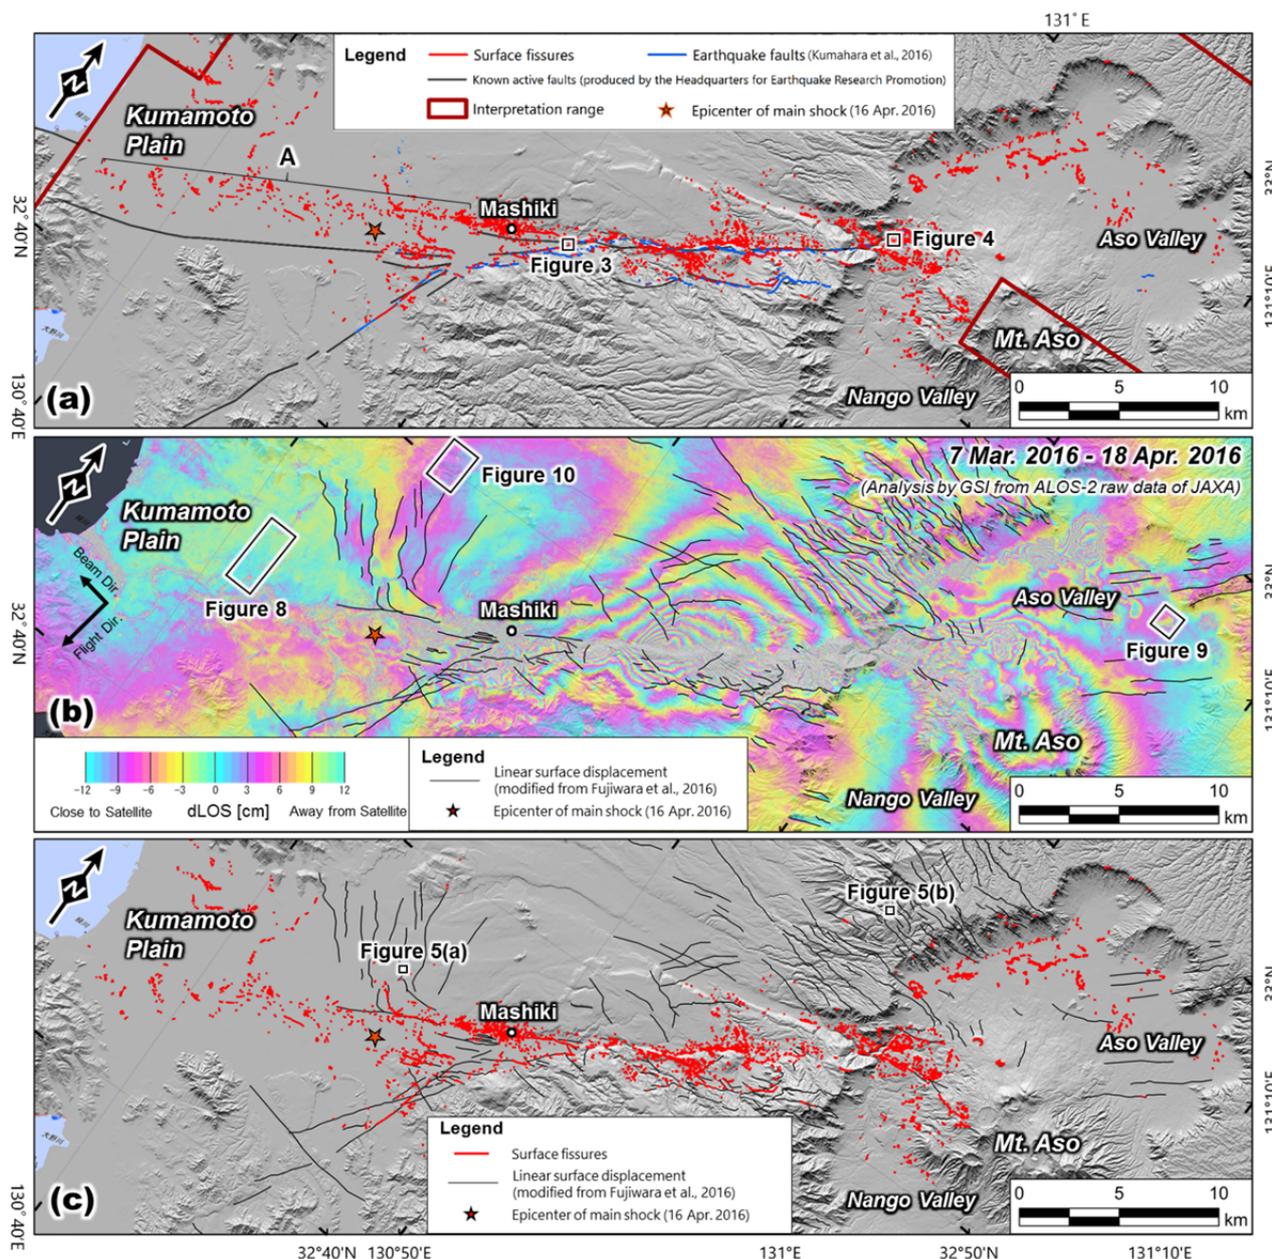
Figure 2. (a) Surface fissure distribution map for the 2016 Kumamoto Earthquake interpreted from ortho-mosaic images. (b) SAR interferogram showing linear surface displacements (modified from Fujiwara et al., 2016). (c) The surface fissures of Figure 2(a) superposed with the linear surface displacements of Figure 2(b).

Figure 2(a) shows the distribution of surface fissures associated with the 2016 Kumamoto Earthquake, which were extracted by the traditional method of ortho-mosaic image interpretation. They are distributed linearly along known active faults (black lines in Figure 2(a)). Most of the surface earthquake faults (Kumahara et al., 2016; blue lines in Figure 2(a)) confirmed in the field survey were extracted, except for those in the mountains. In addition, a linear fissure group crosses the Kumamoto plain (A in Figure 2(a)) from downtown Mashiki Town, where extreme damage occurred. Although active underground faults have been reported here (Yoshimi et al., 2018), no fault displacement topography was observed on the ground. Furthermore, fissures associated with liquefaction or large lateral movement of the ground mass (Nakano et al., 2016a; Tsuji et al., 2017; Fujiwara et al., 2017 etc.) were also extracted locally in Aso Valley.

The interpreted surface fissures are divided into three types according to their formation mechanism: fissures due to surface earthquake faulting, fissures associated with liquefaction, and fissures caused by gravitational deformation. Among these, examples of surface earthquake faults interpreted from aerial photos and UAV videos are shown below.

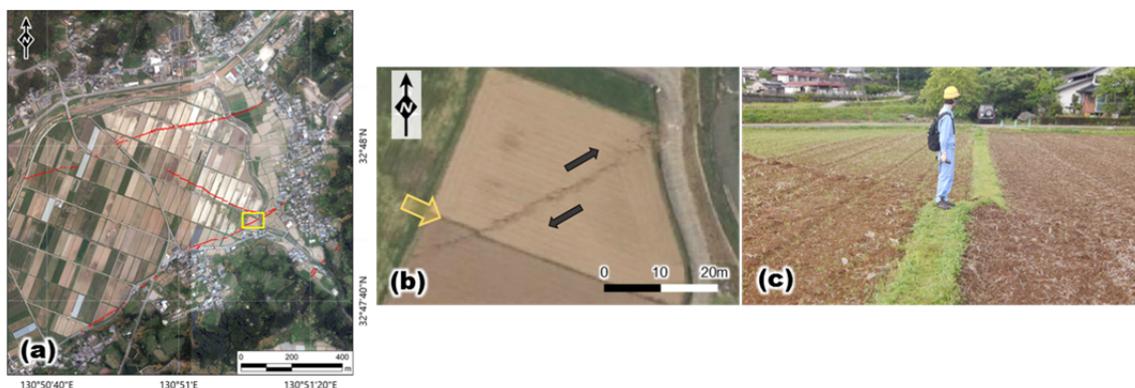
Figure 3. An example surface earthquake fault that appeared in Mitake district, Mashiki Town (location shown in Figure 2(a)). (a) Red lines show the trace of the surface earthquake fault (the background is an ortho-mosaic image taken on April 16, 2016). (b) Enlarged image (single image) within the yellow frame of (a). (c) Ground photo taken at the yellow arrow location in (b).

In the ortho-mosaic image, fissures with linear or en échelon continuity and notable lateral displacement are considered to be due to surface earthquake faulting (e.g. Figure 3). In Mitake district, Mashiki Town, right lateral slip of approximately 0.7 m was confirmed by the field survey (Figure 3).

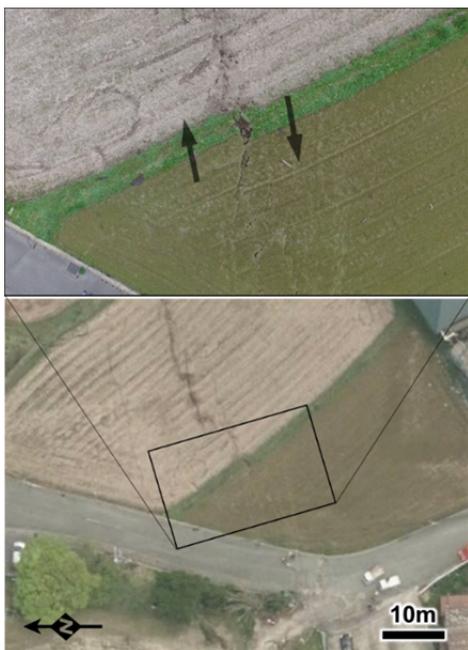
Figure 4. UAV video image of surface earthquake faults that appeared in Kawayo district, Minamiaso Village (upper figure) and aerial photograph (single image) of the same area (lower figure).

Figure 4 compares aerial images with those captured from the UAV video of surface earthquake faults in Kawayo district, Minamiaso Village. The blurred surface earthquake faults in the aerial photo can be clearly identified by their en échelon structure in the UAV image. Figure 2(b) shows the linear surface displacements derived from the SAR interferograms (Fujiwara et al., 2016). Figure 2(c) shows the surface fissures of Figure 2(a) superposed with the linear surface displacements of Figure 2(b). This reveals that the SAR interferogram can extract even minor surface displacements and those in the mountainous area under the forest (Figure 5), which cannot be extracted by ortho-mosaic image interpretation. As described above, surface fissure distribution mapping is useful for detecting the distribution of ground failure over a wide area. However, interpretation using only conventional aerial photo (ortho-mosaic image) is limited, and is more effective when UAV video and SAR interferograms are combined.

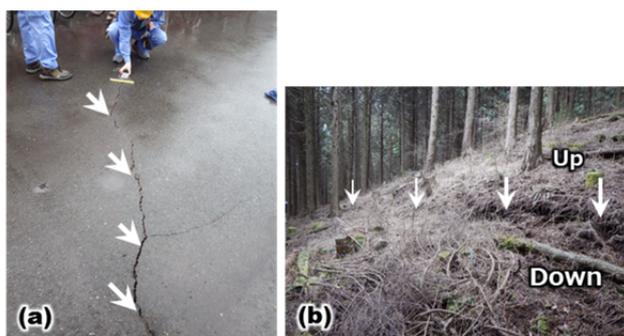
Figure 5. (a) Slight surface crack (shown by white arrows) that appeared in Kengun district, Kumamoto City (location shown in Figure 2(c)). (b) Surface earthquake fault (shown by white arrows) confirmed in the mountains in the northwest part of the outer rim of the Aso caldera (location shown in Figure 2(c)).

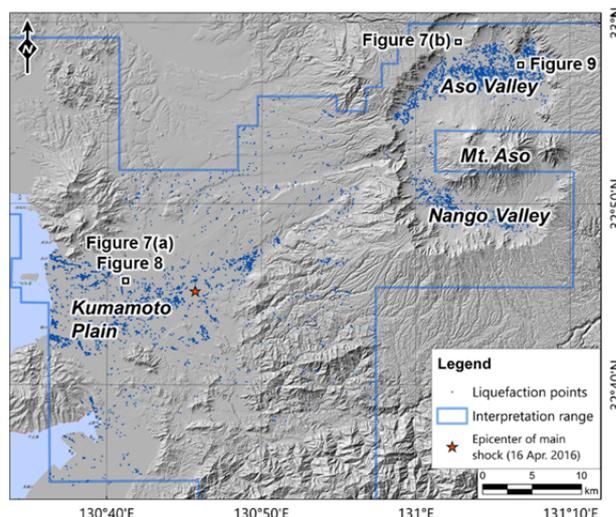
Figure 6. Distribution map of liquefied areas (sand volcanoes) associated with the 2016 Kumamoto Earthquake extracted by ortho-mosaic image interpretation.

Figure 6 shows the distribution of liquefied areas (sand volcanoes) associated with the 2016 Kumamoto Earthquake, extracted by ortho-mosaic image interpretation. Liquefaction was intensive in the Kumamoto plain, Aso Valley, and Nango Valley. Normal sand volcanoes have a white to brown color under dry conditions (Figure 7(a)), but dark gray color spots appear in Aso Valley due to the eruption of black scoria and a high ground water level (Fig. 7(b)). Although field confirmation of liquefaction sites is rarely conducted, we observed no significant differences from the liquefaction distribution map produced by Wakamatsu et al. (2017), which was based on similar aerial photo interpretation and field survey.

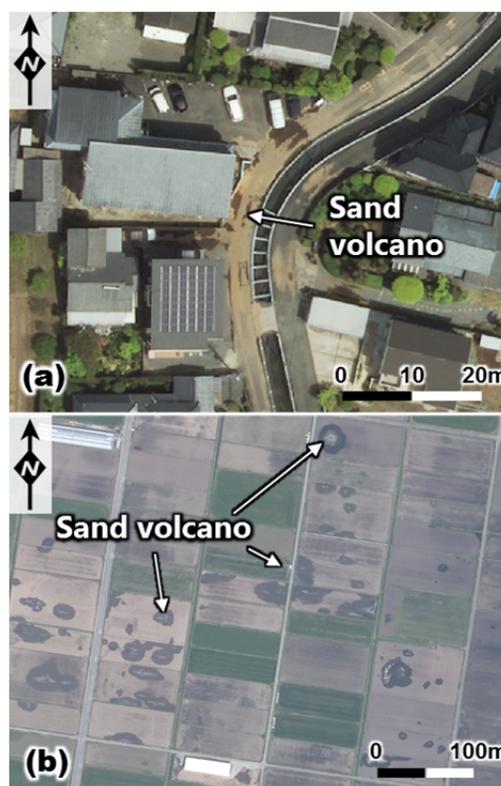
Figure 7. (a) Normal sand volcanoes in Kumamoto city area (location shown in Figure 6), and (b) dark gray sand volcanoes in Aso Valley (location shown in Figure 6).

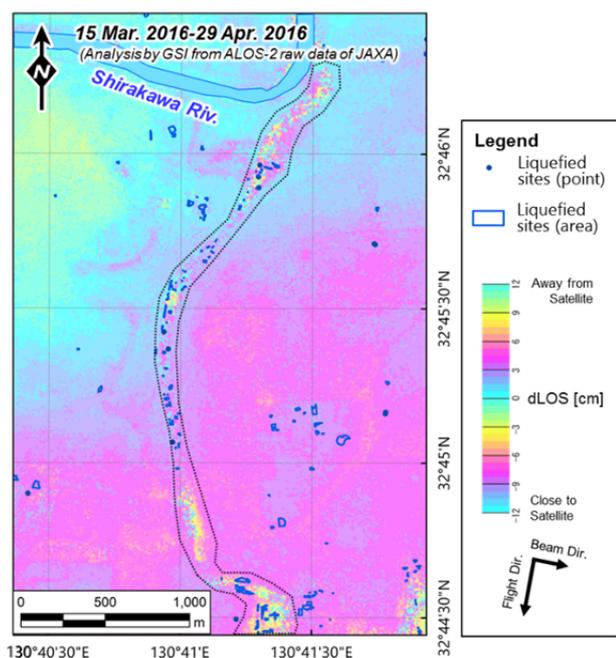
Figure 8. Noise-like phase change (region surrounded by black dotted lines) associated with liquefaction (sand volcanoes) in Kumamoto city area and distribution of liquefaction interpreted from aerial photos.

As described above, in the liquefied area, the coherence of SAR interferograms decreases and appears as a noise-like phase change. Figure 8 shows the example of the Kumamoto earthquake. In the Kumamoto city area, we observed a belt-shaped noise-like phase change meandering in the north-south direction. In this area, liquefaction damage was also confirmed by ortho-mosaic image interpretation and the field survey (Wakamatsu et al., 2017 etc.); thus, we presume that coherence of the SAR interferograms was reduced by the sand volcanoes.

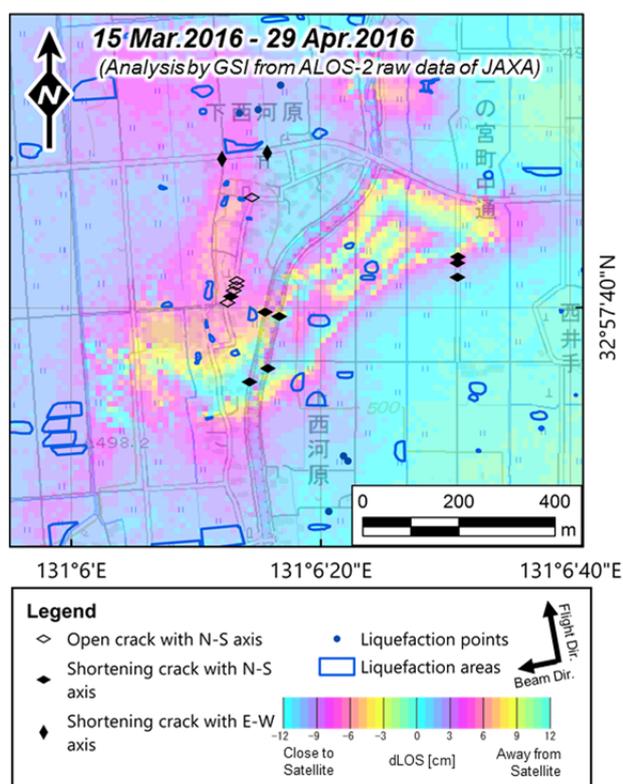
Figure 9. Phase change of lateral movement of ground surface associated with liquefaction on the SAR interferogram at Aso Valley (position shown in Figure 6), liquefaction sites distribution and surface displacements identified by field survey.

Unlike the decrease of coherence associated with sand volcanoes, the ground mass can also move laterally due to liquefaction without much change in the condition of the ground surface. An example of this was observed in Aso Valley induced by the Kumamoto Earthquake (Figure 9). Although it is difficult to quantify the amount and direction of displacement from the SAR interferogram, the field survey revealed clear surface displacements with opening and shortening cracks in this area (Figure 9).

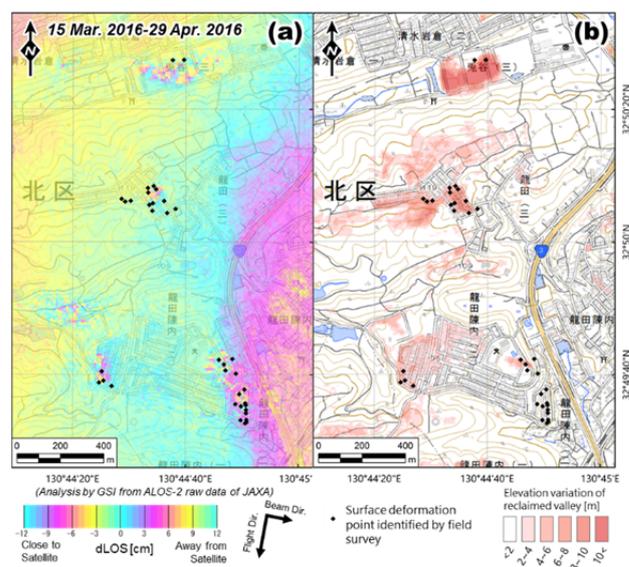
Figure 10. (a) An Example of phase change of reclaimed valley deformation on SAR interferogram, (b) reclaimed valley distribution map created by using SfM-MVS technique. Black diamond marks in both figures show the position of surface deformation found out by field survey.

Figure 10(a) shows an example of a phase change indicating deformation of reclaimed valley. As described above, these phase changes have the appearance of noise-like spots, but the amount of deformation cannot be

identified. However, the area of deformation is largely identifiable. As a result of site investigations, deformation (e.g. surface cracks) of surface structures (roads, building foundations, retaining walls) was observed in the phase change area (black diamond marks in Figure 10).

Figure 10(b) shows the reclaimed valley distribution map created by the difference between the pseudo DEM generated from aerial photos using the SfM-MVS technique and the post-construction DEM of the same area as Figure 10(a). The deformation area detected by InSAR almost coincides with the area of reclaimed valley. Thus, deformation of reclaimed valley, which is difficult to identify in aerial photographs (ortho-mosaic images) can be extracted using InSAR. It is possible that InSAR can also be used to extract deformed reclaimed valley over broader earthquake disaster areas.
